Tactile safety inspection of high-level fabric

REPORT Hailes Castle PIC148

October 2022

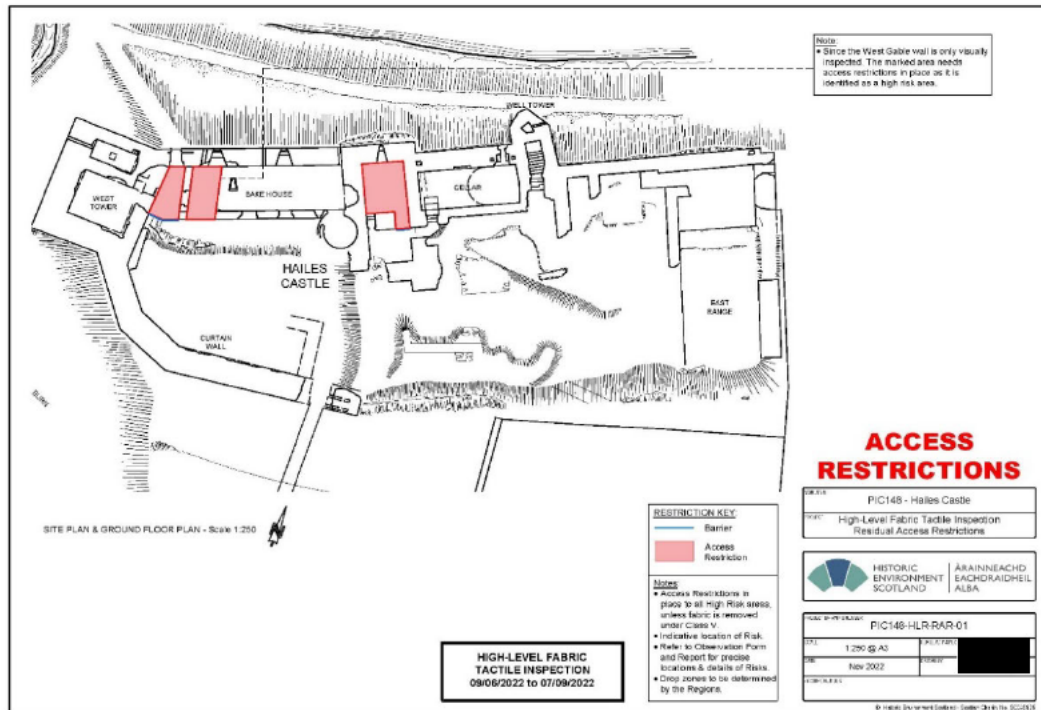
[PIC148-HLR-RAR-01](#)

- Chapel: The West Gable was not inspected as it was clear from visual inspection at familiarisation visit that it is potentially unstable. There is a central section of extremely open jointed eroded small build masonry on the gable's west face. Cracks are also apparent on the inner east face and the gable head wall above is very slender. (See Access Restriction Plan)
- West Tower: The North East Corner is a slender loft pinnacle remnant, there are vertical cracks between mid 20th century roughracking piers buttressing to the two wall tusk ends of the lost east wall and north wall.
- East Tower: The interior face at the North West corner has an area of unstable wall core just under the wallhead, survey perceived the unstable condition of the exposed high level corework on the interior faces of the tower. (See Access Restriction Plan)
