HIGH-LEVEL TACTILE INSPECTIONS

SAMPLING PHASE 1
REPORT

Doune Castle and Roman Camp
PIC061

HISTORIC
ENVIRONMENT
SCOTLAND

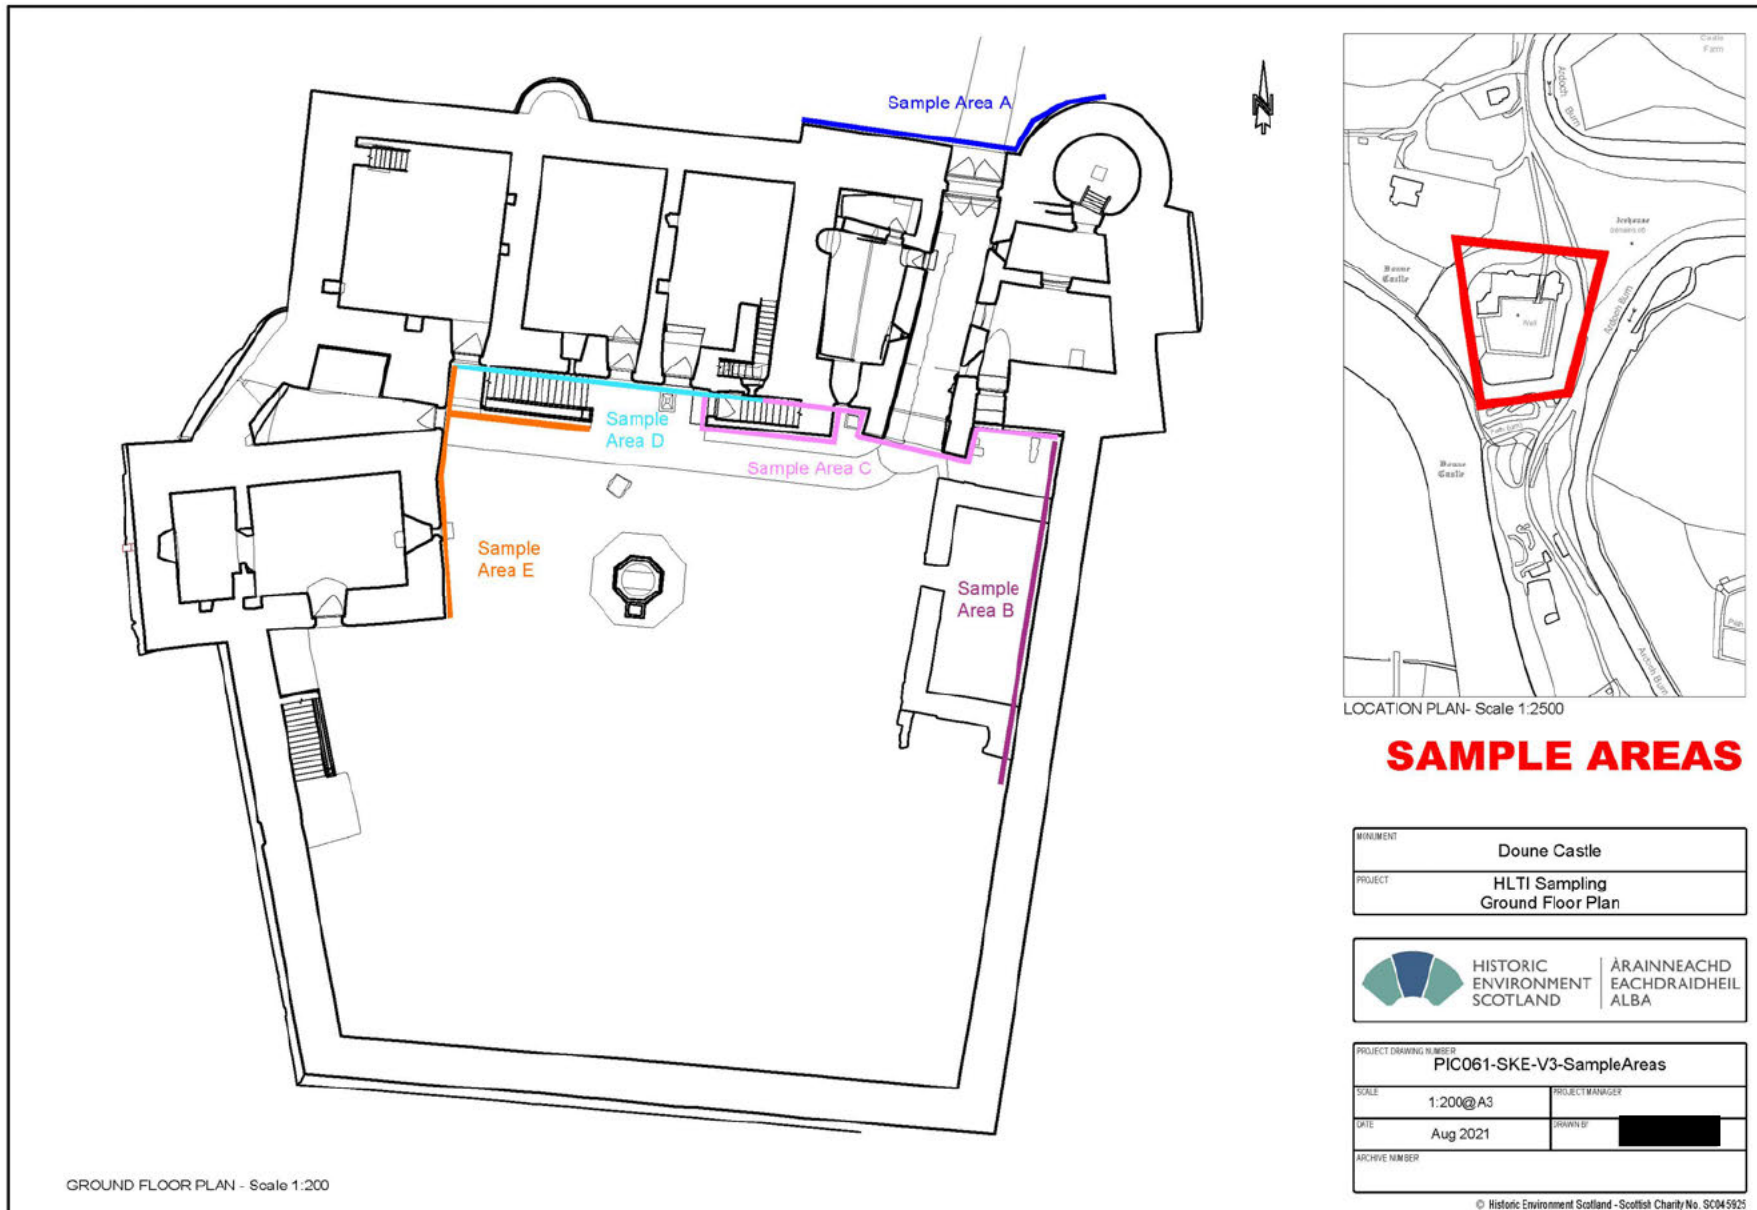
Click on link to open drawing in PDF viewer: [PIC061-SKE-V3-SampleAreas](#)

<i>Area:</i>	<i>Colour:</i>	<i>Sample Area Name:</i>
A	Blue	External North Elevation above main entrance and North West elevation of Tower
B	Red	West internal Elevation of Courtyard
C	Pink	East half of South facing Courtyard wall
D	Cyan	South facing external elevation of Great Hall
E	Orange	East facing external elevatin of Kitchen

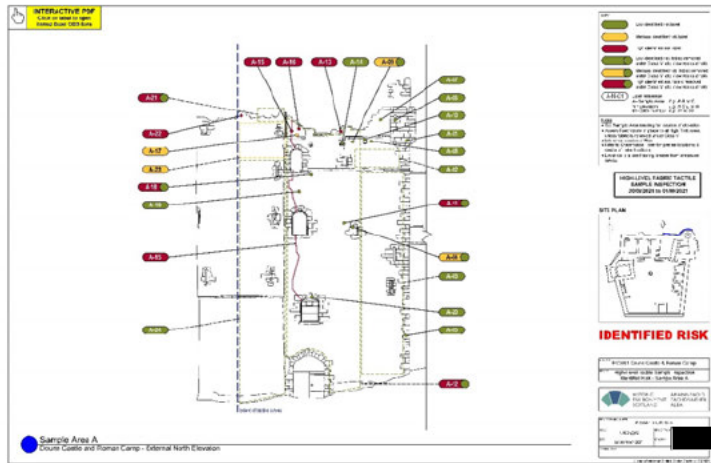
Sample Area A

The most significant observations were found on the North external elevation, which contains the only entrance into and out of the Castle. Here, large stones were found to be loose on the wall head, extensive areas of delaminating stone and a large area of several square meters of de-bonded outer skin of the wall face within the tower to the left of the main entrance. The loose stones on the wall head and delaminating stone were addressed promptly by the MCU by re-bedding and descaling, utilising the MEWP on site. The de-bonded outer skin of the wall is being managed by a risk assessment and controlled access until repairs can be made.
