# HIGH-LEVEL TACTILE INSPECTIONS

SAMPLING PHASE 1  
REPORT  
Dryburgh Abbey  
PIC141

Title:	High-Level Tactile Sample Inspection Project Phase 1 Report PIC141 Dryburgh Abbey
Authors:	[REDACTED]
Document created:	August 2021
Reviewed by:	[REDACTED]
Date Reviewed:	27/08/2021
Approved by:	[REDACTED]
Date of Approval:	30/08/2021
Version Number:	V0200

<b>PIC ID # ↓</b>	<b>PIC141</b>	<b>Site name</b>	<b>Dryburgh Abbey</b>		
<b>Inspection start</b>	26/07/2021	<b>Inspection end</b>	29/07/2021	<b>Submission</b>	30/08/2021
<b>Lead HBFA</b>	[REDACTED]				
<b>Sample Inspectors</b>	[REDACTED]

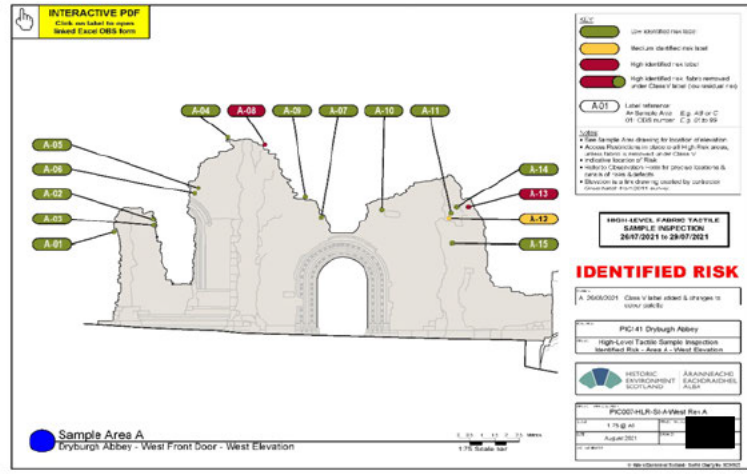
Sample Area A

High and medium risks were found on the West Front Door, resulting from detached and partially detached masonry at high-level.

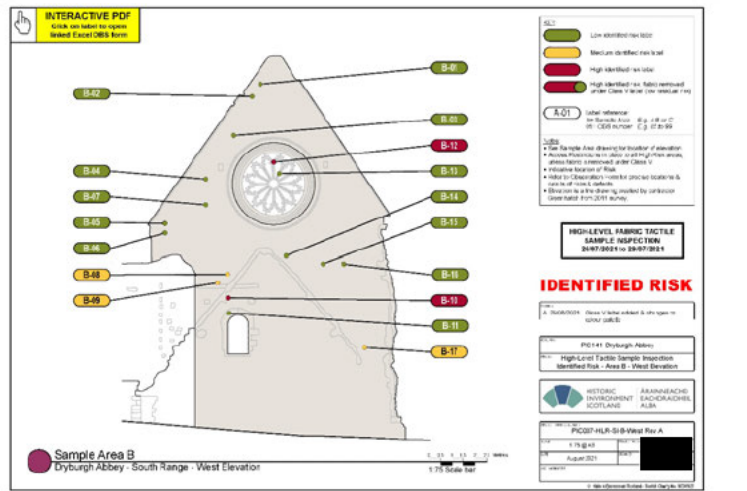
Sample Area B

High risks were found on the West and South elevations of the South range, resulting from partially detached masonry and areas where there were multiple loose stones at risk of falling from height. Areas of high risk would result in barriers being put in place to protect life from the risk of falls, however, as the entire site is already barriered, no further barriers have been erected but site staff and the local MCU depot have been notified of the identified risks.

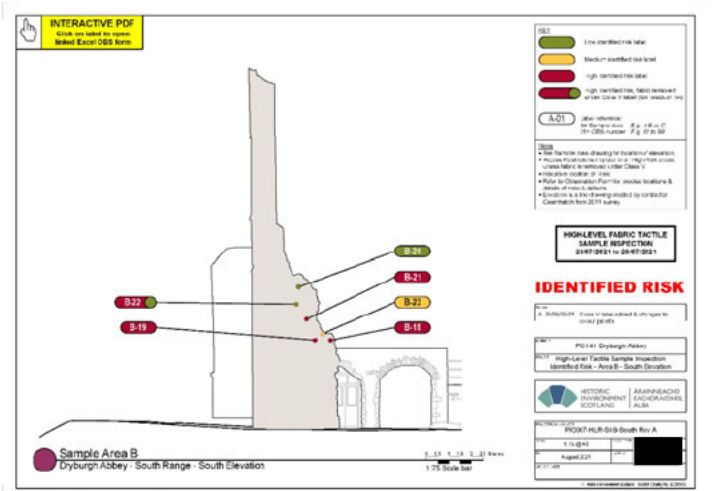
On the South elevation a fully detached stone was found, which was at immediate risk of falling and presented a hazard to life. This was removed in a controlled manner under Class V consent to maintain the safety of the site.
