High Level Masonry Project  
Tactile safety inspection of high-level fabric

REPORT  
URQUHART CASTLE  
PIC323

Title:	Tactile safety inspection of high-level fabric Report PIC323 Urquhart Castle
Authors:

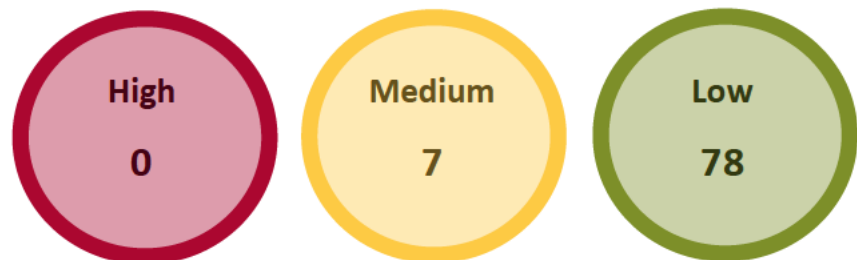
## Residual Risk

After Inspection Action

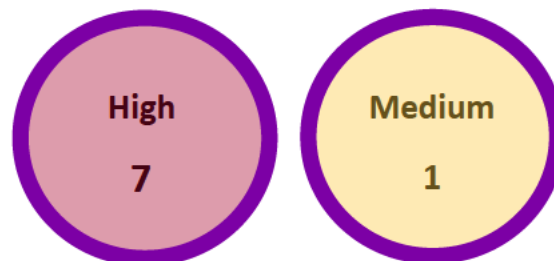
## Residual Risk

Mitigated with applied Access Restriction in place
